Manhole Inspection Summary

Manhole # S13EE2002MH

Insp Date: **7/27/06 10:37 AM**

Location Address: **2205 CREST RD** Cross Street: **RIDGEDALE RD**

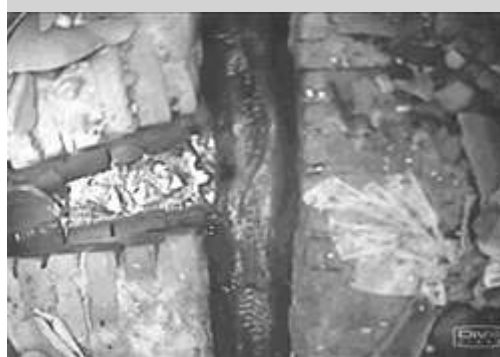
Top View

Evidence of surcharge - Bench debris.
Bench deterioration.

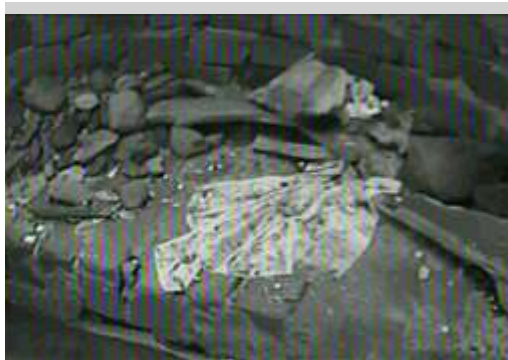
Defect

Barrel and Channel deterioration.
Evidence of surcharge - Bench debris.

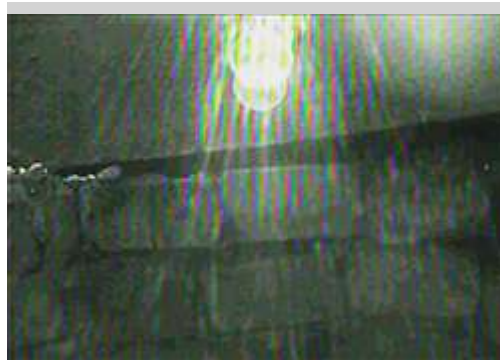
Defect

Frame leaks. Adjustment deterioration
and infiltration.

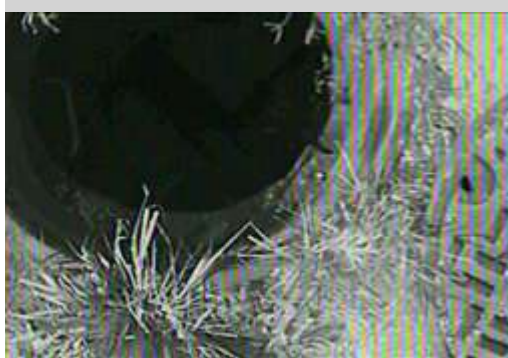
Defect

Frame offset. Adjustment deterioration
and infiltration.

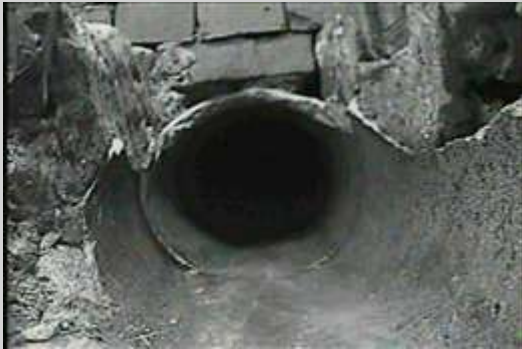
8 in. Circular Gravity Sewer Pipe Out @ 12 O'Clock

Infiltration: **Evidence** Pipe Seal Cond: **Broken**

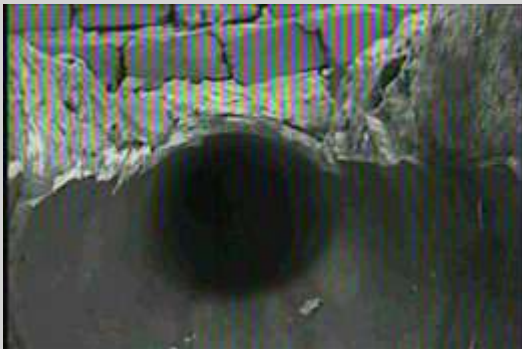
6 in. Circular Gravity Sewer Pipe In @ 6 O'Clock

Infiltration: **None** Pipe Seal Cond: **Cracked**

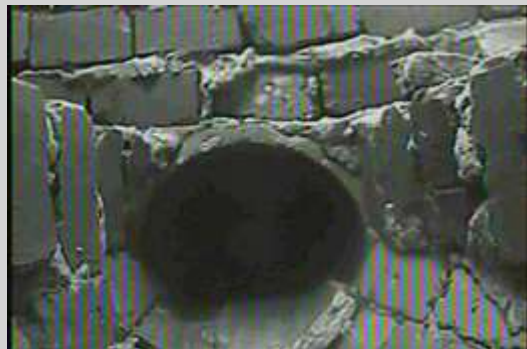
Pipe In @ 9 O'Clock

Barrel deterioration and infiltration. Channel deterioration.

Infiltration: **None** Pipe Seal Cond: **Cracked**
